St Edward's Church, Roath

**Community Facilities & Accessibility
Project at St Edward's, Roath
Volume 2: Surveys & Reports**

Compiled by St Edward's Committee, Roath Parish

August 2018

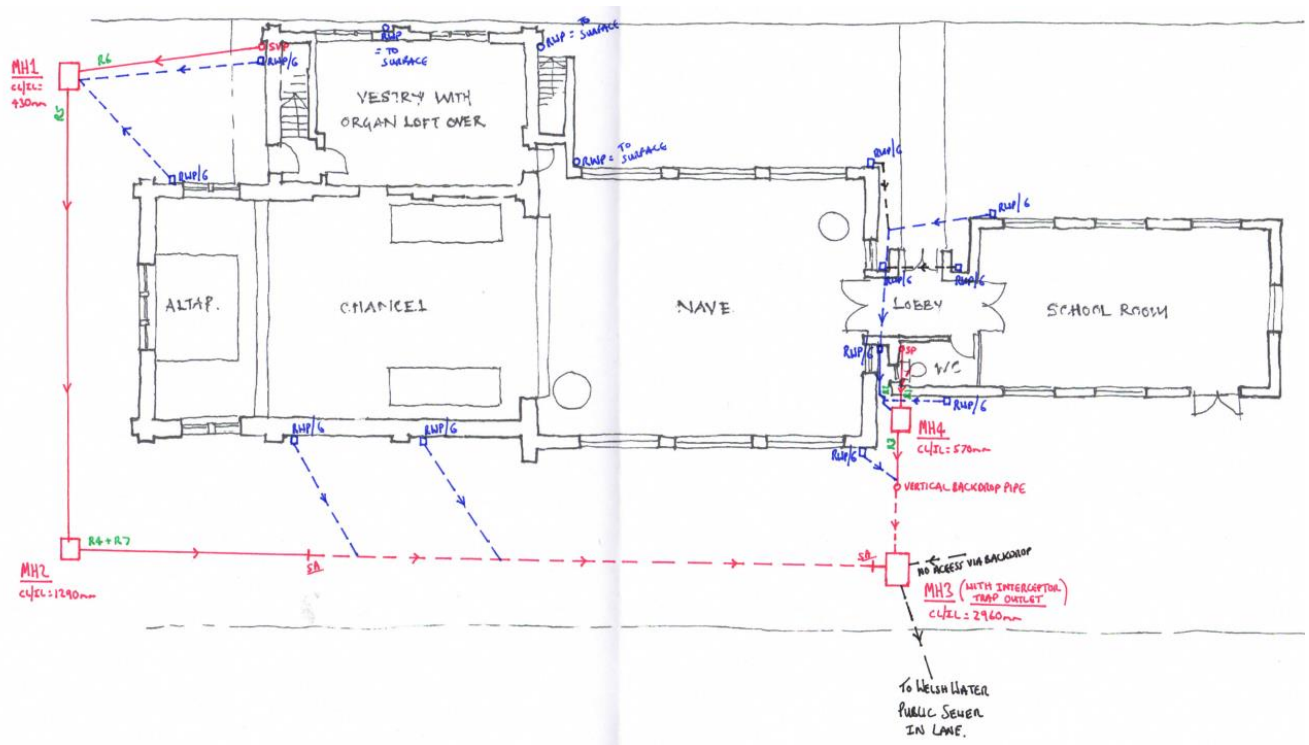
2.1 The sketch below shows the drainage system as demonstrated by the CCTV survey.

- 2.2 This shows some key differences to the layout we had assumed following our first site visit. The key conclusion is that all of the drainage on site discharges to the Welsh Water sewer in the lane via MH3.

- 2.3 The other significant conclusion is that the WC in the vestry does connect to this system.
- 2.4 At this stage depths of manholes have been measured but the relative cover levels have only been assessed visually. Based on this it appears that the existing falls are reasonable. They vary from about 1 in 40 to 1 in 120.

- 2.5 Generally the condition of the drainage around the school room and MH4 is reasonable. A few minor open joints and some limited root ingress has been noted.

- 2.6 The condition of the drainage from the vestry WC, MH 1, MH2 and the run along the north of the church is significantly worse. Displaced joints, open joints, cracks, poor manhole benching, low points and significant root ingress have been noted.

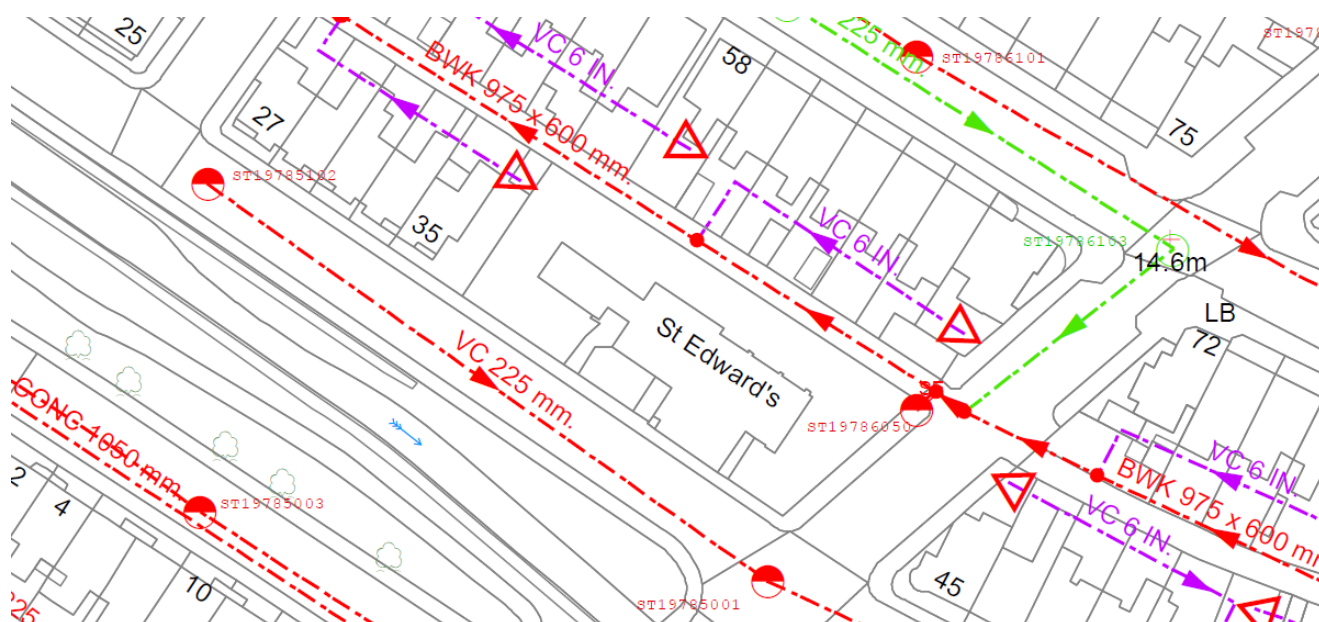
- 2.10 This shows that MH 3 most likely forms the connection point for the church and the pipe labelled VC 6 IN to the main sewer which runs in the lane tot the north of the church. This is a substantial 975x600mm brick sewer and was most likely constructed when the surrounding houses were built. In addition there is a small diameter sewer in the road to the south of the church.

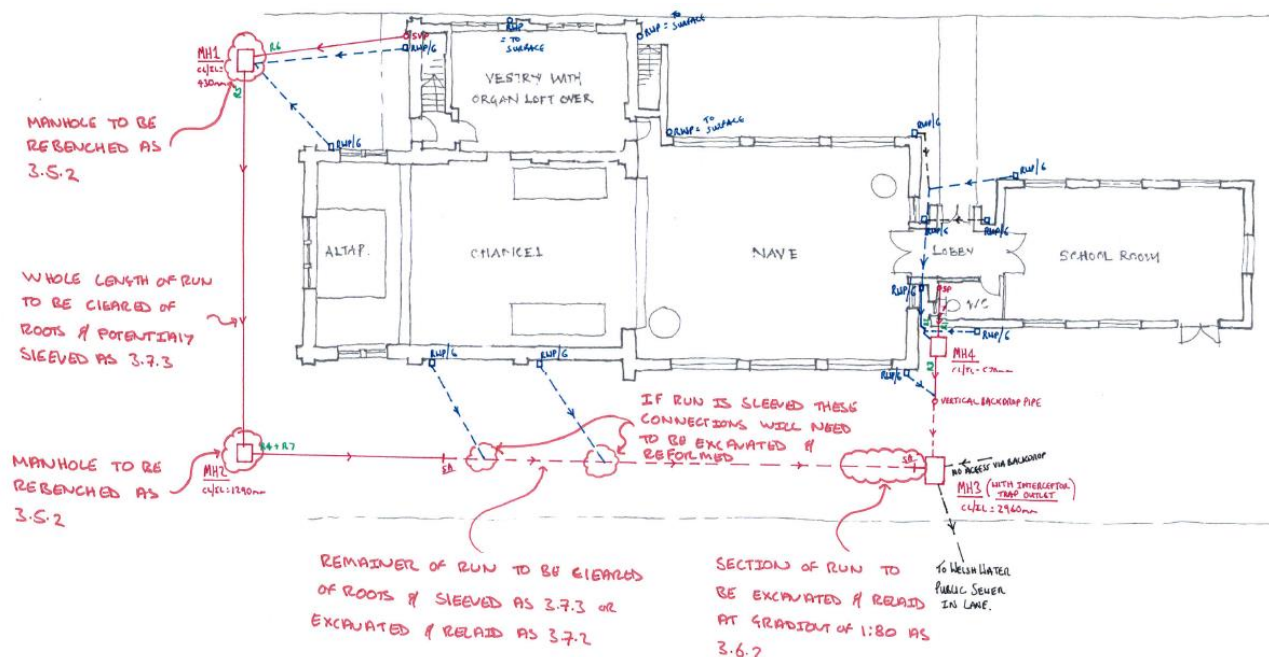
- 3.1 There are three main defects requiring remediation
 - Benching of manholes MH1 and MH2
 - Root ingress and displaced joints to drainage runs between MH1/ MH2 and MH2 / MH3
 - Low point of drainage run between MH2 / MH3 at MH3 connection
- 3.2 The remainder of the drainage has minor issues which provided the system is properly maintained should not cause significant problems.
- 3.3 A portion of the run MH2 / MH3 has not been surveyed because of the existing defects restricted access to the CCTV camera. We recommend that during the works this run is surveyed once access has been facilitated, this should be reviewed for any further defects requiring repair.
- 3.4 The recommended repairs are shown on the sketch below

- 3.5.1 The benching and layout of both manholes are causing restrictions to the flow but MH1 is more significant than MH2.
- 3.5.2 The existing benching should be broken out and removed. New benching should be constructed so as not to restrict the flow with inverts formed from channel pipes, slopes not greater flatter than 1 in 30 and a minimum 20mm high strength concrete topping. Where existing pipe levels do not allow for a smooth fall over the chamber they should be excavated and adjusted locally avoiding low spots.
- 3.5.3 We recommend that both manholes are re-benched. MH2 could be left as existing but this would remain as a defect which may cause future blockages.

- 3.6.1 The low point in this pipe is holding water which will tend to hold debris and restrict the flow. There is also some minor damage to the backdrop within MH3.
- 3.6.2 The pipe should be excavated locally and re-laid back from the manhole as far as required (anticipated 2-3m) to achieve a fall of 1 in 80. Any damaged sections of pipe should be replaced and a root protection barrier should be included in the trench. In addition the broken backdrop pipe should be replaced.

- 3.7.2 There are two main options for remediating these defects. The pipework could be excavated and re-laid replacing damaged sections of pipe and including a root barrier to the outside of the pipe. Excavating adjacent to the existing trees will require some cutting of roots and working around major roots to minimise damage to the trees. As discussed in section 3.5 the 2-3m of this run at MH3 is recommended to be excavated and relined.

- 3.7.4 We recommend the run MH2 / MH3 is fully remediated with either solution and the run MH1 / MH2 has the roots removed only. The displaced joints would remain as defects in the run MH1 / MH2 which may cause future blockages but as this run is shorter and there is less vegetation surrounding it the risks are reduced.

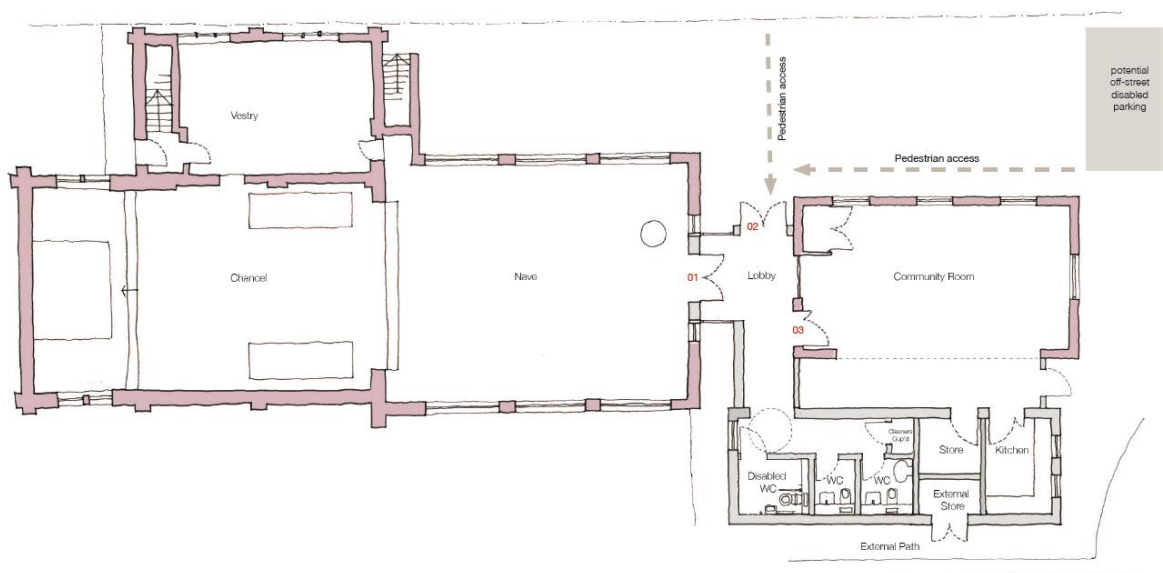
- 4.1 Our understanding at this stage is that the client is considering an extension of the school room to the north as shown on the plan below. This will require the creation of a flat area, by reducing ground levels, over the footprint of the extension and surrounding path.

- 4.3 There are two existing manholes in this area of the site and a number of drainage runs. These manholes and some of the drainage runs will need to be maintained as they serve the existing rain water pipes to the front of the school room. The drainage for the existing school room WC could be removed.

- 4.6 Our recommendation is that a simple topographical survey is undertaken to position the manholes and the plan is adjusted so the manholes sit within the external path between the building and the retaining wall.

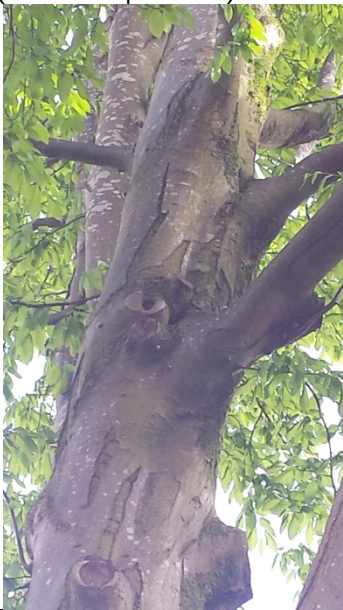
3	Hornbeam trees, Holly, Honeysuckle, Spanish Bluebell. No bat potential associated with trees
4	<p>Hornbeam in extension works footprint with hole next to knot on Main trunk (Moderate potential).</p>

In case a bat is present, hand tools (e.g. crowbar) should be used if practicable to remove any boarding, raised tiles or flashing. Before felling the Hornbeam, the rot hole should be checked for bats. Contractors should be briefed on the low risk that bats could be encountered, and if a bat were discovered, all work in the area should cease immediately and the project ecologist or Natural Resources Wales be contacted for advice.

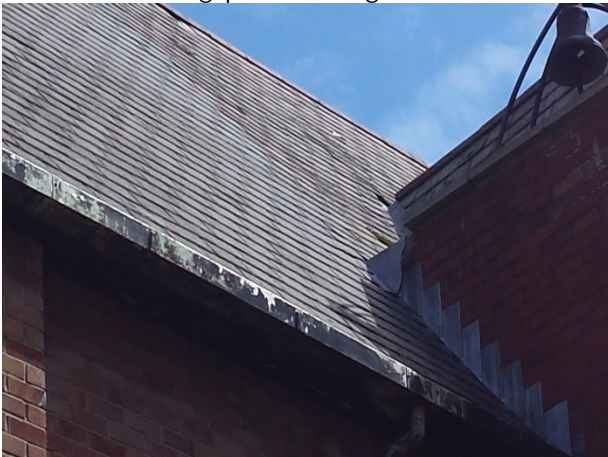
9	Small number of gaps under ridge tiles & roof tiles

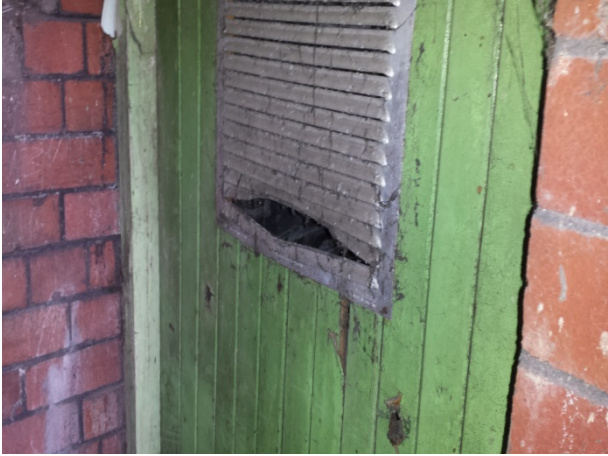
10	Crevice into wall under roof edge
11	Gaps into cellar vents on door.

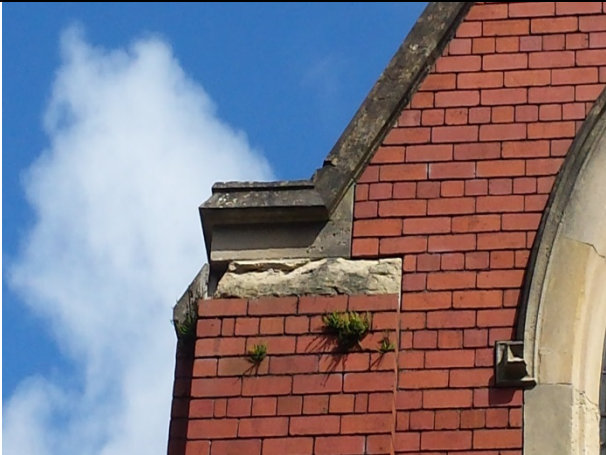
12	Missing mortar & gaps into crevices in walls to southern elevation of main building

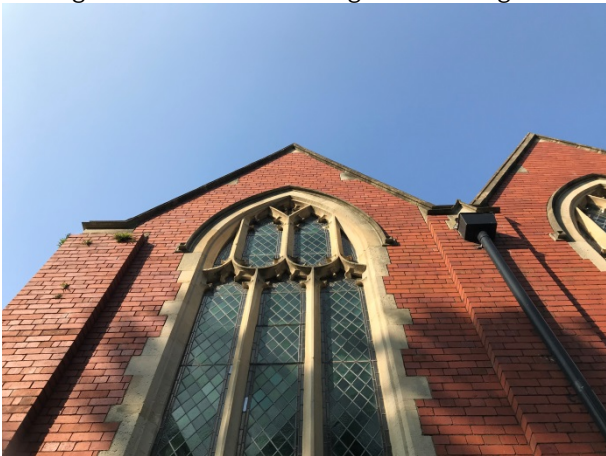
13	<p>Missing mortar & crevice into gable end ridge of Vestry at apex of gable</p>

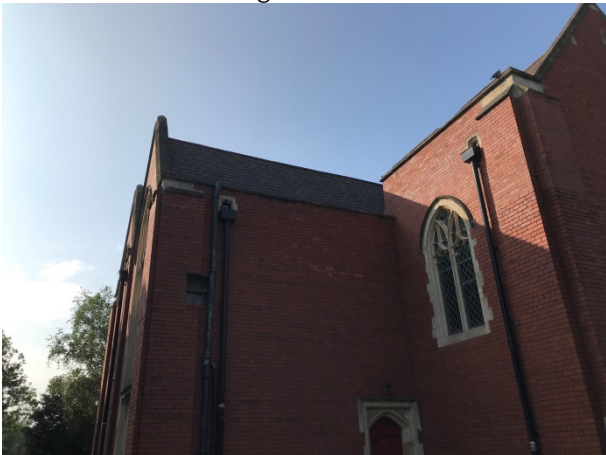
14	<p>Small gaps into brickwork associated with downpipes/stonework to eastern corner of main building.</p>
