St Edward's Church, Roath

**Community Facilities & Accessibility
Project at St Edward's, Roath
Volume 2: Surveys & Reports**

Compiled by St Edward's Committee, Roath Parish

August 2018

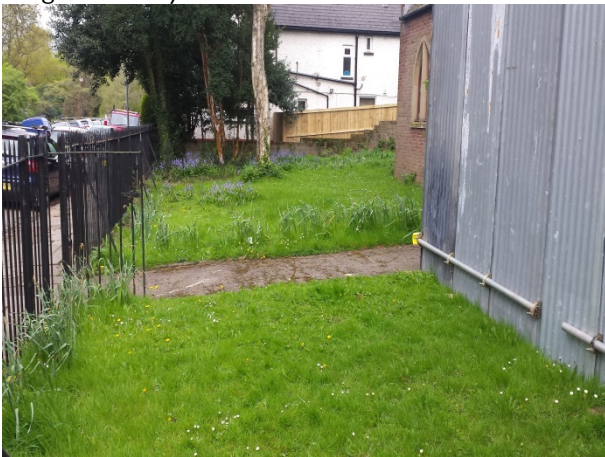
3	Hornbeam trees, Holly, Honeysuckle, Spanish Bluebell. No bat potential associated with trees
4	<p>Hornbeam in extension works footprint with hole next to knot on Main trunk (Moderate potential).</p>

In case a bat is present, hand tools (e.g. crowbar) should be used if practicable to remove any boarding, raised tiles or flashing. Before felling the Hornbeam, the rot hole should be checked for bats. Contractors should be briefed on the low risk that bats could be encountered, and if a bat were discovered, all work in the area should cease immediately and the project ecologist or Natural Resources Wales be contacted for advice.
